TESTING SUMMARY

Wisconsin Stormceptor® Field Monitoring Summary

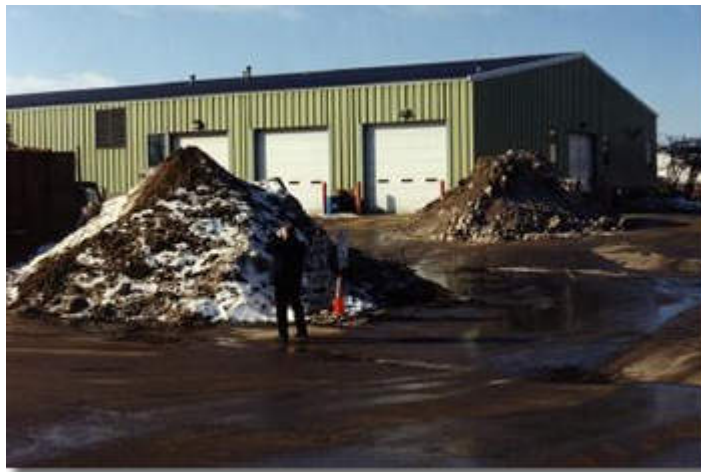
Taken in February 1998, this picture shows piles of used snow and sand.

A Stormceptor® STC 6000 was installed at an existing public works yard in Madison, Wisconsin in May, 1996. The site was selected for retrofit due to the high potential for pollutant loadings and lack of stormwater quality control. The unit drains 4.3 acres (1.74 ha) of the yard, all highly impervious. The works yard is used for yard waste drop-off, fueling, storage and cleaning of city vehicles and storage of sand and salt for road de-icing. Pictures of the site are shown below.

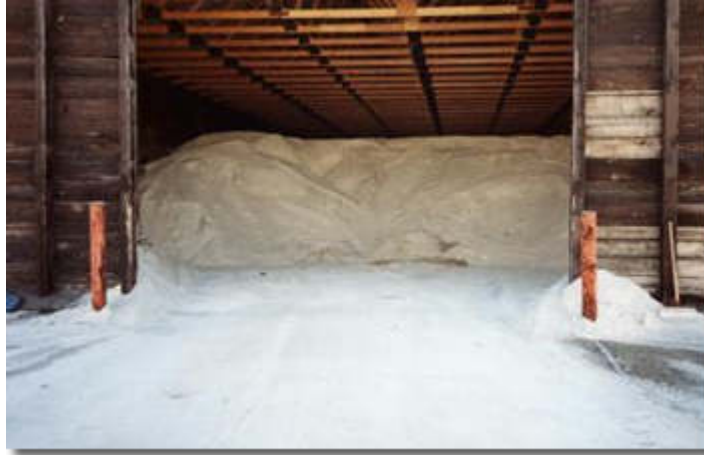
While this salt storage is in a covered area, there is considerable spillage outside.

The salt is mixed with sand on the pavement outside of the covered area and the mixed salt/sand pile is left exposed outside.

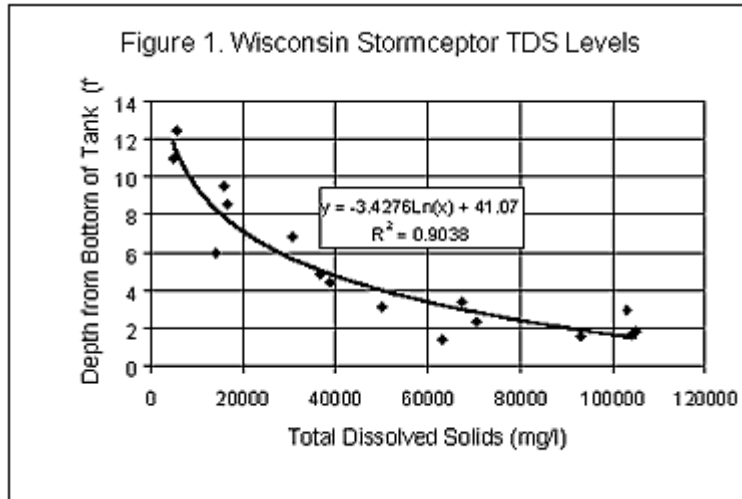
The high salt concentrations may have created hindered settling conditions and could have created a chemocline (stratified conditions). Stratification would reduce the effective volume of storage and hence retention time in the Stormceptor[®]. The current sizing guidelines for the Stormceptor[®] are based on upstream drainage area and separator storage to achieve a certain performance target. Stratification would effectively reduce the storage volume making the unit a much smaller separator and less effective for the period of time that the unit was stratified. The vertical profile of total dissolved solids during pumpout is shown in [Figure 1](#).

Extremely high Total Dissolved Solids (TDS) concentrations were measured in the tank prior to cleanout. The majority of the tank had TDS concentrations > 20,000 mg/l with the bottom of the tank having TDS concentrations in excess of 100,000 mg/l). The high concentrations of TDS are thought to be the result of the high salt loading on the site (salt storage and distribution center).

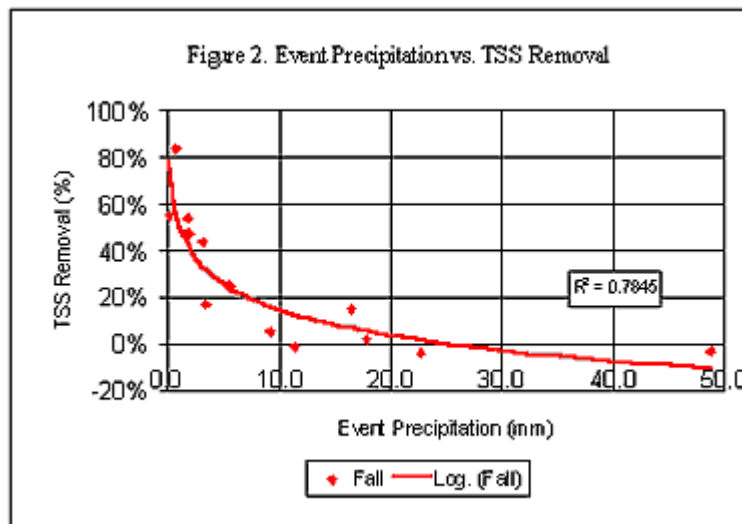
Figures 2 and 3 provide a comparison of TSS removal for the fall period of 1996 with the winter/spring period of 1997. Figure 2 shows good agreement between TSS removal and storm size for the fall (no salt) period ($r^2 = 0.78$) while there is an extremely poor relationship between storm size and TSS removal for the winter/spring (salt) period ($r^2 = 0.12$).

Both figures indicate that the effectiveness of the Stormceptor® for TSS decreases as the storm size increases. It should be stressed that these curves are partially a function of the site conditions on the public works yard (continually high TSS loadings with storm size, i.e. no first flush ever due to storage piles, and high salt loadings). The performance would not degrade as quickly with storm size for typical urban applications such as commercial or industrial parking lots that exhibit a first flush effect, the winter/ spring performance may improve without the influence of high salt loadings and summer conditions were not assessed.

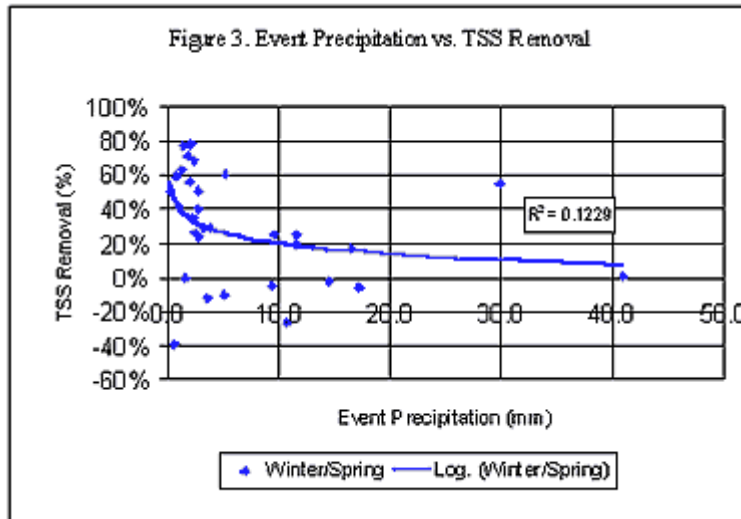
Figure 3 suggests that a high salt content in the Stormceptor® may have affected the settling characteristics.
